# A NEW TECHNIQUE OF FRICTION STIRS FOR REPAIRING CORROSION OF ALUMINUM PLATE

**ABSTRACT:** In the present paper, a new technique from the working principle of Friction stir technologies is introduced and investigated which can be used as a repair corrosion method for aluminum plates. That is to say, this method is based on friction. The pin less tool with its high rotation speed through friction cleans the area affected by corrosion well, and this is also a clear advantage for generating heat between the plate and tool. For repairing pitting corrosion, we added the filler material in the zone affected by corrosion, the rotating tool exerted frictional heat on the filler material and the work piece, which created a thermal field to treat corrosion by fusion and mixing in the corrosion zone. The generated heat comes from frictional and plastic dissipations, in which the friction contributes to the fusion of the filling material with the base metal. Tensile tests were performed to evaluate the mechanical properties of the repaired, corroded, and normal specimens. The mechanical properties of specimens are discussed so that the results of the tensile test showed a significant decreas

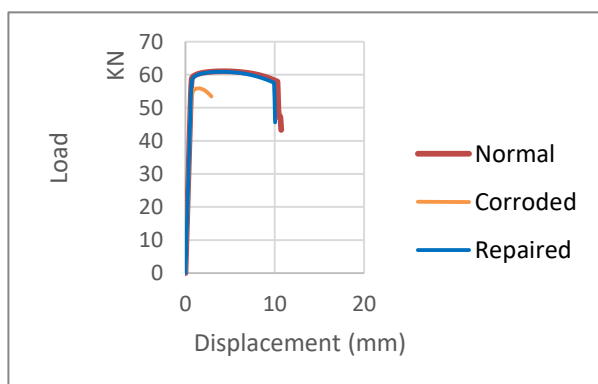
Figure 9 compares the load-displacement curves of a corroded, normal, and repaired plate. The maximum load capacity was determined for the repaired, corroded, and normal specimens (without defects) in Table 4.

Before repair, the corroded plate exhibits a load-displacement curve that indicates structural weakness due to corrosion. This curve shows a reduction in maximum load compared to a normal plate, due to pitting corrosion which weakens the structure by reducing the thickness of the plate.

The geometric characteristics of the load-displacement curve for the repaired specimen are similar to the normal specimen, this is an indication that the repair technique is estimated to increase stiffness and tensile strength.

Friction stir corrosion repair strengthens the structure by filling the corroded zone and reinforcing weakened zones.

Fig.9 Load-displacement curves of the repaired specimen, corroded specimen and normal specimen.

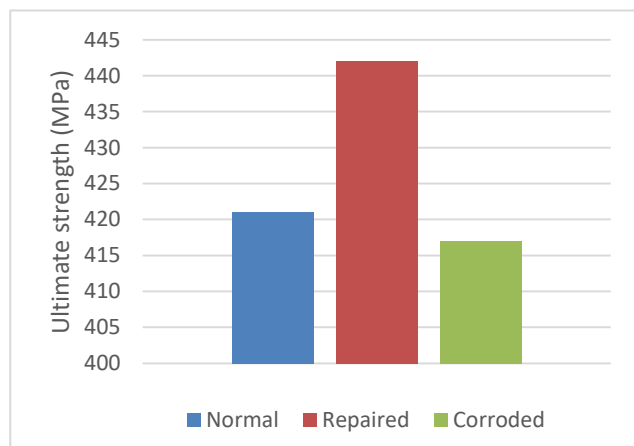
Figure 11 shows the histogram of ultimate strength values. This study proved that the repair technique increases the value of the ultimate strength of the plate so that the untreated corroded plate failed by a value of only 417 MPa, while using the friction stir repair this value increased to reach the value of 442 MPa.

The ultimate strength of a corroded plate is lower than that of a normal plate due to the corrosion, which changes its mechanical properties by weakening the material.

The repaired plate has a higher ultimate strength compared to a corroded plate. The repair process

aims to address the weaknesses introduced by corrosion and restore the plate's structural integrity.

The repaired plate has improved mechanical strength, ensuring it can withstand higher loads than a normal plate, due to filling the corroded zone and reinforcing weakened zones.

**Fig.11 Comparison of ultimate strength of the repaired, corroded and normal specimens**
